# **J. ARONSTEIN**

## **HAZARDOUS FPE CIRCUIT BREAKERS AND PANELS**

*(Updated as of May 25, 2007)*

*Information for Inspectors and Homeowners*

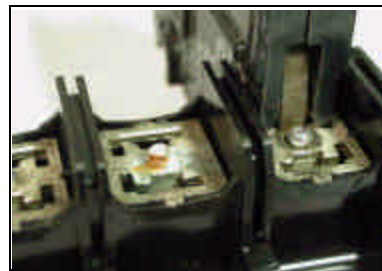
**C. Stab socket on a post, attached with an 8-32 steel screw.**

Of the three types illustrated, the one shown in Figure 2-C is known to have a high probability of deteriorating and overheating of the stab socket structures when subjected to significant current flow. Each individual stab socket plate is connected to its bussbar via a post (spacer), and the assembly is held together by an 8-32 steel screw. FPE panels with this construction are prone to overheating failure. The seven panels of the present study that showed evidence of serious overheating were constructed this way. One example is shown in Figure 3.

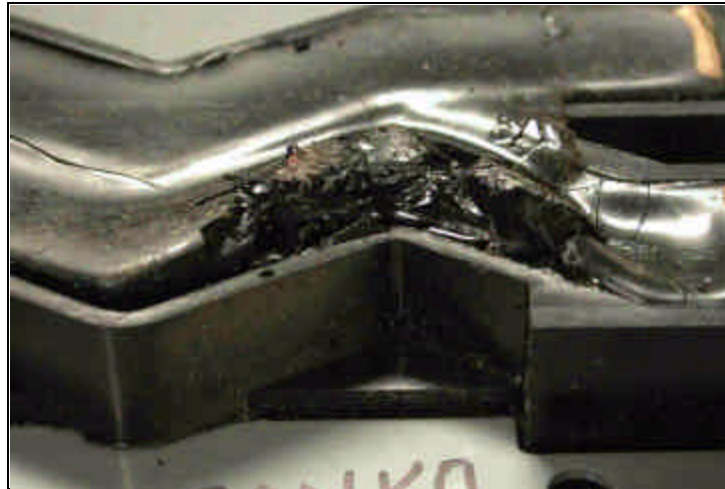
**FIGURE 3 - OVERHEATING AT THE CONTACT BETWEEN THE BUSSBAR AND THE STAB SOCKET ASSEMBLY CAUSED THIS DAMAGE TO THE INSULATION.**  
 (This view is of the backside of the panel. The damage cannot not be seen unless the panel is taken out of the enclosure.)

A more serious failure of this type has been documented.<sup>1</sup> In that instance, the failure had been severe enough to ignite a smoldering fire on the plastic insulating material. The fundamental weakness in this design is the use of a single, relatively flimsy 8-32 screw to hold a structure together that can feed up to four half-width breakers with a total "ampacity" (rated circuit capacity) up to about 160 Amps. Figure 4 shows how the stab socket plate and post are attached to the bussbar.

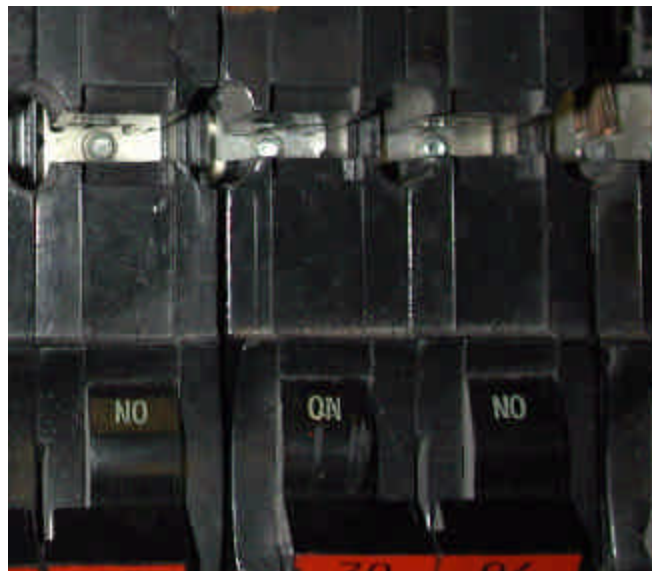
Inspectors can, however, determine if a particular FPE panel has this type of construction, and, to a limited extent, whether it has failing bussbar interconnections that have previously overheated. With the panel cover off, for this type of panel, you can see the ends of the screws holding the stab socket plate as shown in Figure 5. (Note: If you see slotted screwheads, that's a different type of panel construction.) The stab socket plates and the visible ends of the screws should have a bright metallic look. Darkening, discoloration, or signs of corrosion most likely indicate past episodes of abnormal overheating.

**FIGURE 5 - THE ENDS OF THE SCREWS HOLDING THE STAB SOCKET PLATES ARE VISIBLE BETWEEN THE TWO ROWS OF BREAKERS. THIS IDENTIFIES IT AS A PANEL OF THE TYPE SHOWN IN FIGURE 2-C**

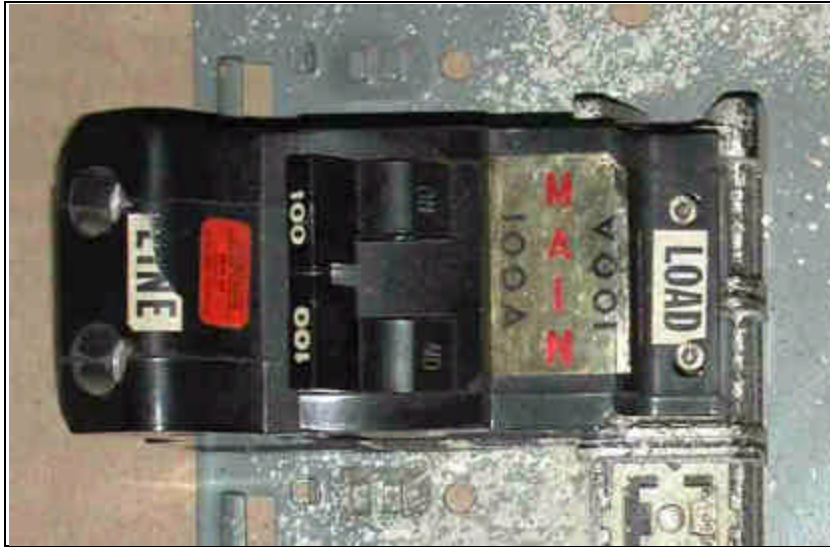
Some FPE Stab-Lok® panels have 100-amp main breakers that feed into the bussbars through the same plate and post system. In this design, the two main breaker output terminals do not have the stab type contact. Instead, each one is screwed down to a plate the same size as the stab socket plate, but which has a threaded hole in it instead of the stab openings. As with the plate and post assembly, the screws clamping the main breaker terminals are size 8-32, which is absurdly small for clamping the terminals of a 100-amp main breaker.

**FIGURE 6 - FPE 100-AMP MAIN BREAKER CONNECTS TO THE BUSBARS THROUGH THE PLATE & POST CONFIGURATION, USING ONE SOCKET-HEAD 8-32 SCREW AT EACH TERMINAL TO ATTACH TO THE CONTACT PLATE.  
(The heads of the 8-32 terminal clamping screws are seen above and below the "LOAD" label.)**

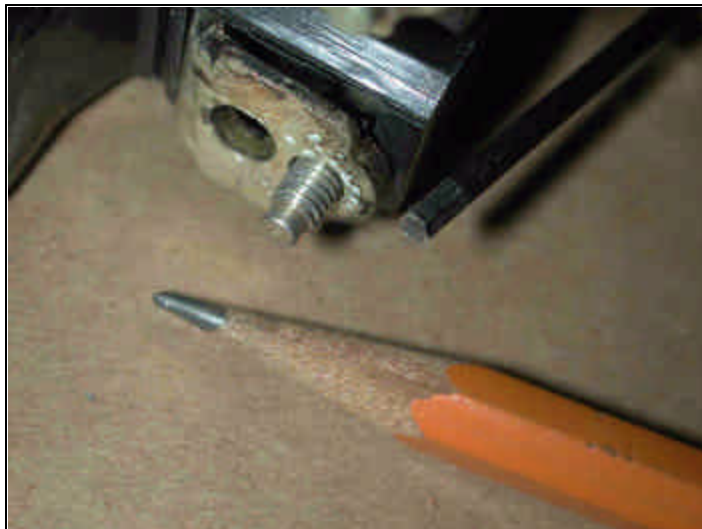
To put the diameter of the 8-32 screw in perspective, it is the same size as used on common receptacles for connecting #14 or #12 copper wire (for 15- and 20-amp circuits), and has a diameter of only about 5/32". An FPE panel and main breaker of this type is shown in Figure 6. The main breaker's output terminal mounting screws and the tiny Allen-wrench that fits them are shown in Figure 7.

**FIGURE 7 - ONE LOAD-SIDE CONTACT AND ITS 8-32 CLAMPING SCREW, ON THE FPE 100-AMP MAIN BREAKER OF FIG. 6. THE SCREW-HEAD TAKES A 3/32" ALLEN WRENCH, WHICH IS ONLY SLIGHTLY LARGER THAN THE LEAD OF THE #2 PENCIL.  
(The larger hole provides clearance for the screw protruding from the stab contact plate)**

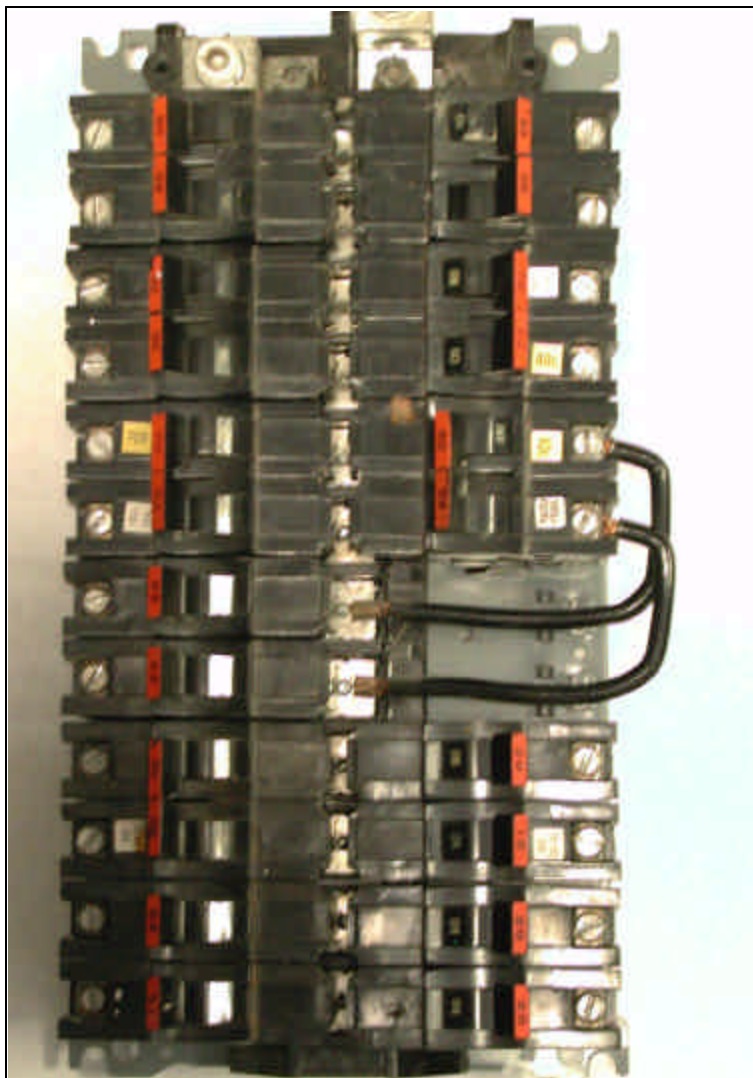
**FIGURE 8 - FPE STAB-LOK® "RULE-OF-SIX" (SPLIT-BUS) PANEL WITH NO MAIN BREAKER. THE JUMPER CABLES ON THE RIGHT SIDE FEED THE LOWER SECTION.**

On first glance, the FPE Stab-Lok® panel previously shown in Figure 8 looks normal. In fact, however, it clearly demonstrates several of the hazardous failure modes discussed in the previous sections. It is one of 28 collected for the recent testing. It is from a home built in 1974, whose new owners had determined in 1999 that it should be replaced. Their decision to replace it was in part prompted by information available on the internet regarding FPE breaker problems.<sup>7</sup> According to the homeowner, who sent it to me for examination and testing, *"We recently had it replaced and found the breaker to the dryer fried in just the way described. Our electrician was astonished. Two others we had bids from dismissed our concerns with contempt."*<sup>8</sup>

There are additional problems in this panel. Overheating damage occurred to the insulation on the backside of the panel. Further, in addition to the dryer breaker that failed (jammed) in the home, two other two-pole breakers from this same panel failed in the lab testing. All this in a panel that looked OK from the front!

Everything in the home was functioning. The dryer worked. Why wouldn't it, since the circuit breaker was jammed with its contacts closed? Keep in mind that this panel is one of the "rule-of-six" configuration. Before they replaced this panel, the homeowners unknowingly had a situation where, essentially, the clothes dryer was wired straight through to the power line transformer on the pole, with no functional circuit protection at all.

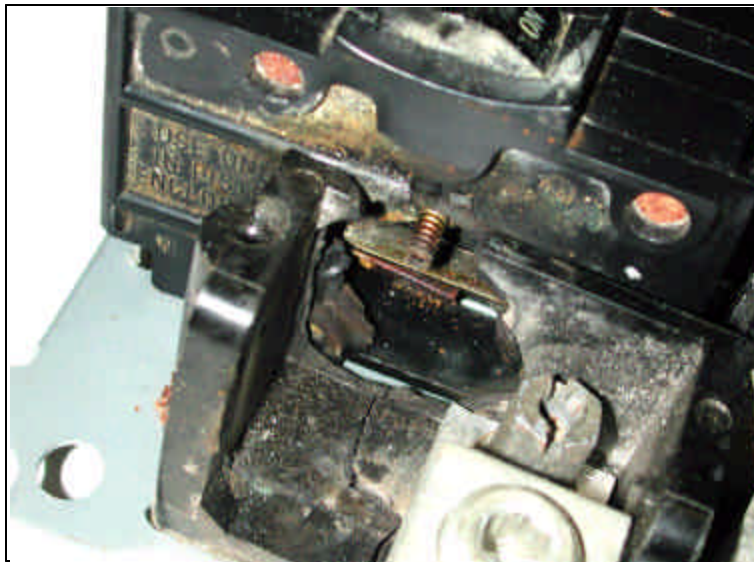
**FIGURE 9 - VIEW DOWN TOWARD UPPER RIGHT OF PANEL SHOWN IN FIG. 8.**

Viewing the panel from the front, some subtle signs of overheating (as previously discussed) are evident. These are subtle compared to the view looking down at the top right (dryer) breaker, as in Figure 9. The main service cable connector has been rotated out of the way for better visibility of the damage. The plastic insulator is burnt and cracked. The breaker's internal mechanism can be seen through the hole burned through its side. Figures 10 and 11 show the damage to the separate items.

**THE FPE STAB-LOK® TWO-POLE 30-AMP BREAKER FED THE CLOTHES DRYER.**

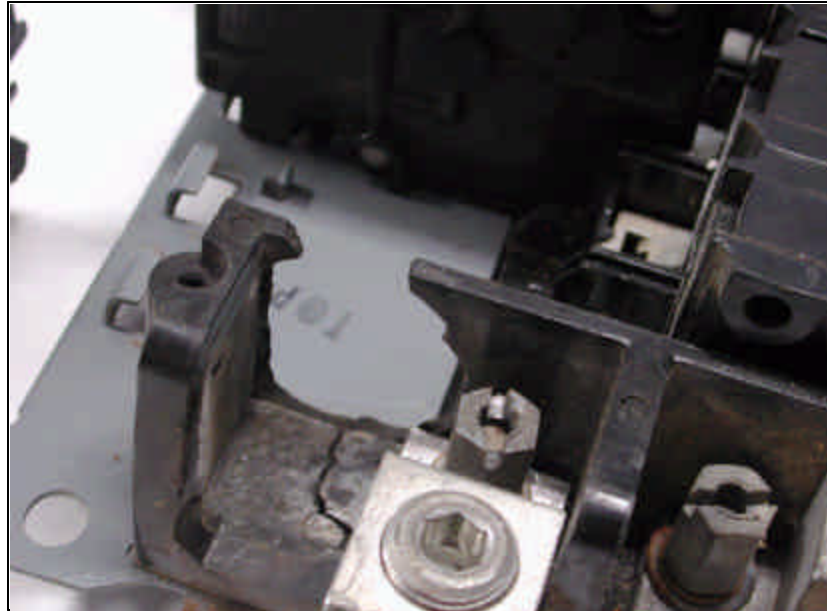
**FIGURE 10** - THE DAMAGE TO THE INSULATING STRUCTURE OF THE PANEL (FIG. 8) IS MORE CLEARLY VISIBLE WITH THE BREAKER REMOVED.

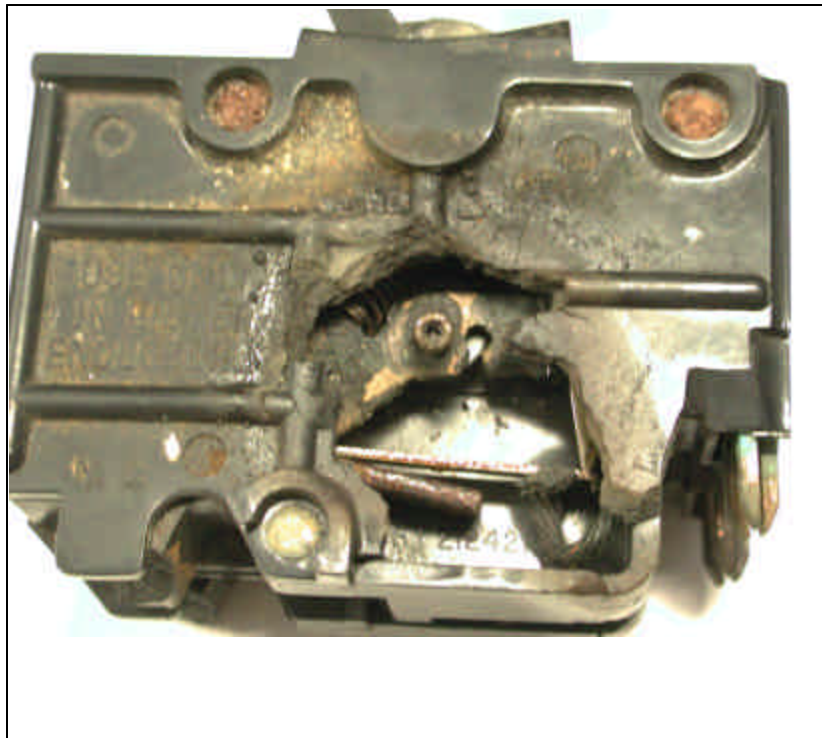
**FIGURE 11** - THE FAILED FPE STAB-LOK® DRYER BREAKER (UPPER RIGHT, FIG. 8)

The damage to the breaker, from some previous short circuit or failure event, is exactly as had been demonstrated in the tests done for CPSC.<sup>2,3,4</sup> Those tests demonstrated that, when an FPE breaker jammed and the current exceeded about 300% of the breaker's rating, the side of the breaker disintegrated and/or ignited from the heat being generated within the breaker. This is due to resistive heating of the breaker's internal current-carrying components, mainly the bimetal element and the flexible copper braid that connects to it. This is not an arcing failure, although the damage to the insulating materials of the breaker and panel sets the stage for an arcing fault to occur.
