# **J. ARONSTEIN**

## **HAZARDOUS FPE CIRCUIT BREAKERS AND PANELS**

*(Updated as of May 25, 2007)*

*Information for Inspectors and Homeowners*

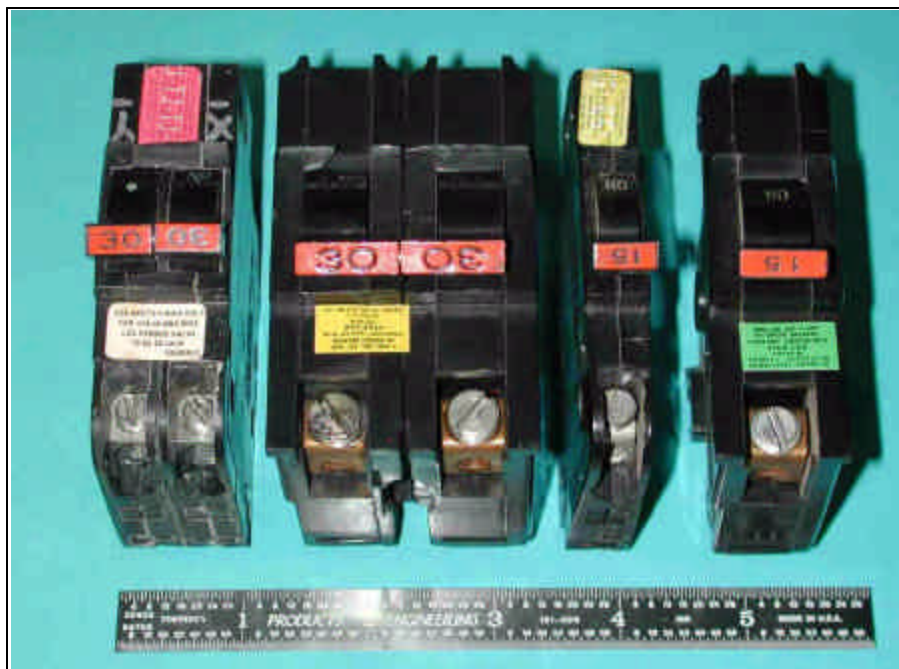
**FIGURE 1 - REPRESENTATIVE SAMPLES OF HALF- AND FULL-WIDTH FPE STAB-LOK® CIRCUIT BREAKERS** (left to right: 1/2-width double pole, full-width double pole, 1/2-width single-pole, full width single-pole)  
*Note that the color and style of the handle varied over the years.*

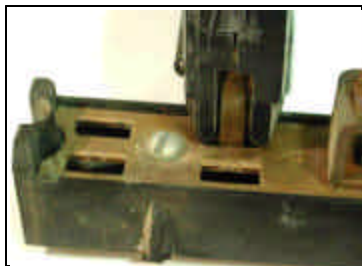
**A. Copper buss bar with punched openings.**

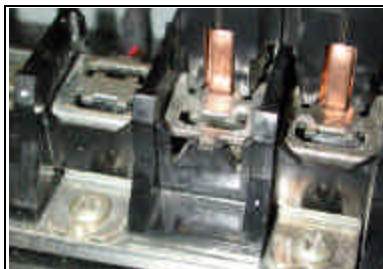
**B. "Z" clip, clamped to . bussbar with 10-32 screw.**

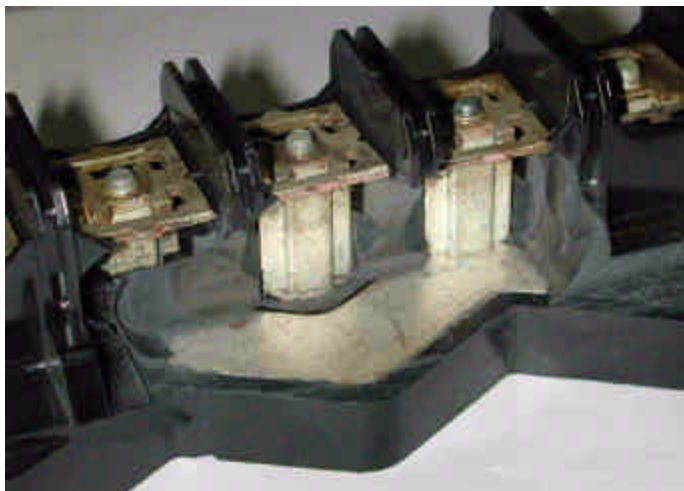
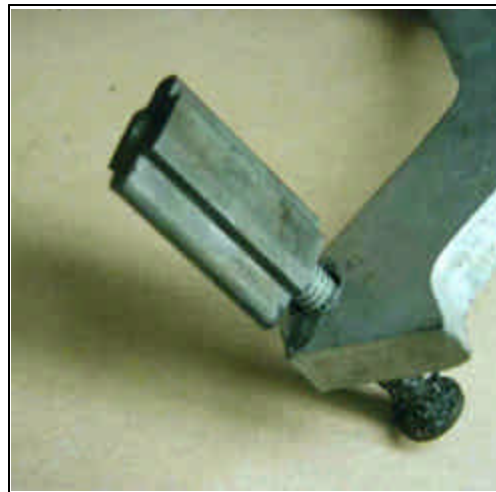
**FIGURE 4 - CONDUCTING PATH FROM BUSSBAR TO STAB SOCKET**

A more serious failure of this type has been documented.<sup>1</sup> In that instance, the failure had been severe enough to ignite a smoldering fire on the plastic insulating material. The fundamental weakness in this design is the use of a single, relatively flimsy 8-32 screw to hold a structure together that can feed up to four half-width breakers with a total "ampacity" (rated circuit capacity) up to about 160 Amps. Figure 4 shows how the stab socket plate and post are attached to the bussbar.

**A. Cutaway - Bussbar, Post, and Stab Socket Plate.**

**B. Bussbar, Screw, and Post**
